mSolve, Building Science Services

Appendix A - Air Sampling Analysis from the Murphy Home Montgomery, AL

Appendix B - Comments on Healthy Homes' expert report

Subject Report: "Inspection of The Fleetwood Factory Built Home Belonging to the Murphy family)" By Bobby Parks of Healthy Homes of Louisiana, LLC, for Lance Gould of Beasley, Allen, Crow, Methinks, Portis & Miles, P.C, Montgomery, AL 36104
No report date, site visit indicated as 5-22-2006 (HHR 5-22-06).

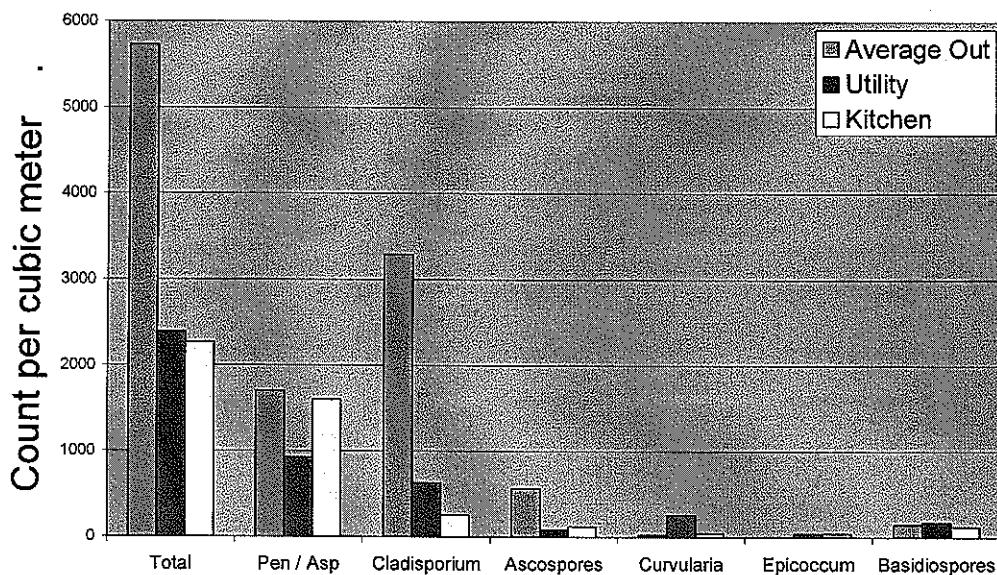
Figure A1. Generally the average outdoor air contains more mold spores than does the inside air - both by total count and by mold type.* Comparing outside to inside mold concentrations is a standard method to evaluate whether unusual amplification of mold is present. This data indicates no unusual amplification.

There are no specific standards for mold levels. Outdoor air could be the sole source of mold found in this home, particularly because the air samples reflects only one point in time and is an average of only 2 outdoor samples. However, the indoor levels do not compare closely with the outdoor concentrations.

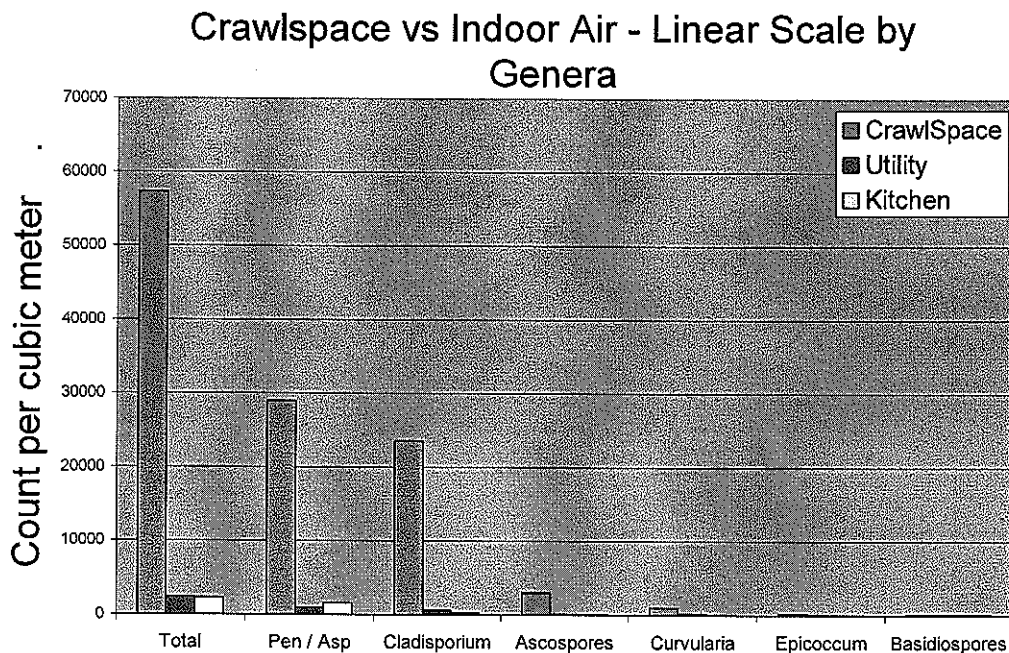
Figure A2. This home interacts with a second outdoor environment from the crawlspace underneath the home. Research shows that some portion of crawlspace air will enter the living area, and if the crawlspace air contains mold spores, these will tag along and enter the living area as well.

Generally, the crawlspace air contains considerably more mold spores than does the inside air. The crawlspace has 23 times higher total mold spore concentration than does the indoor air.

The linear scale used in this chart makes it difficult to compare the relationship between the crawlspace and indoor spore levels because the crawlspace levels are orders of magnitude higher than the indoor air concentrations.

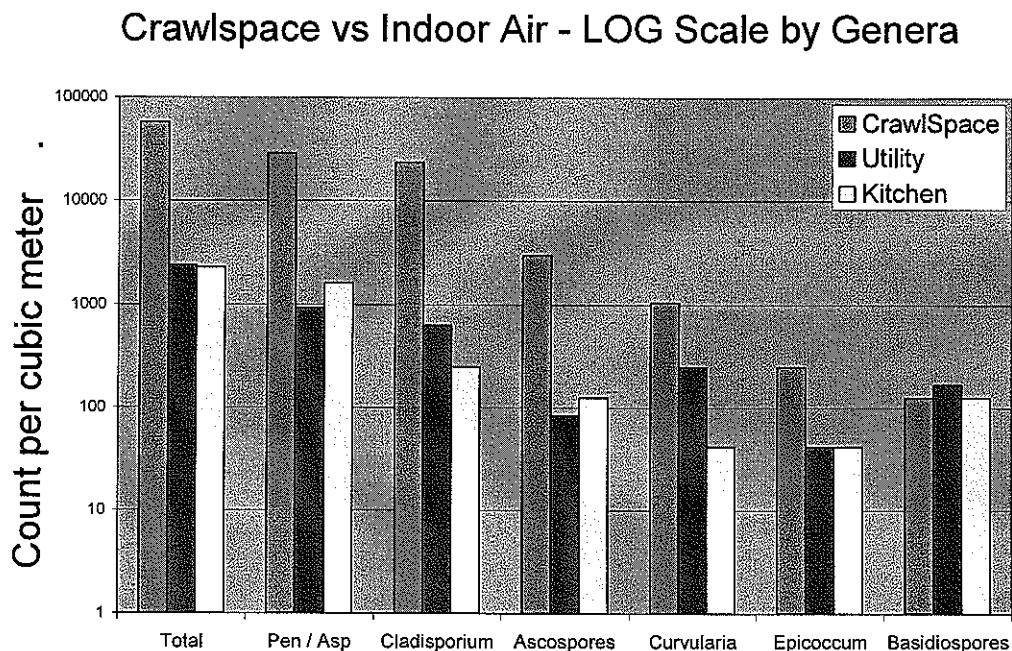
Figure A3. This graph uses a Logarithmic scale to make it easier to compare the relationship between the crawlspace and indoor spore levels. This chart represents the same data as in Figure 2, but the y-axis has been changed to a Log scale.

It is easy to see that there is a strong relationship between the population of molds between the crawlspace and the indoor air; both for the total mold count and by mold type concentrations. This finding strongly suggests that the crawlspace is the dominant influence over the concentrations of molds within the living area.

It is expected that steps to reduce mold concentration in the crawlspace and to reduce air pathways into the home will result in reduced concentrations in the living area of the home.

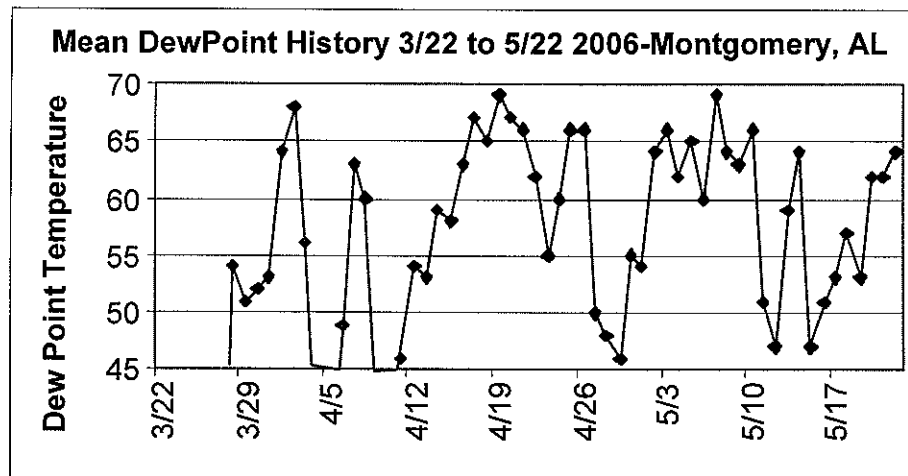
The outdoor dew point conditions prior to the (HHR 5-22-06) inspection were consistently too dry to cause any alleged wall cavity condensation wetting. The following figure shows that for two months before the (HHR 5-22-06) inspection, the mean daily dew point only reached 69F degrees on 2 occasions and the average daily dew point was only 55F degrees. As long as the home is warmer than the outside air condensation is impossible under these conditions. Given the weather history, wall moisture readings of 25% - 40% relative moisture content is not possible.
